# **Debris/Ice/TPS Assessment and Integrated Photographic Analysis for Shuttle Mission STS-54**

**March 1993**

DEBRIS/ICE/TPS ASSESSMENT  
AND  
PHOTOGRAPHIC ANALYSIS  
OF  
SHUTTLE MISSION STS-54

January 13, 1993

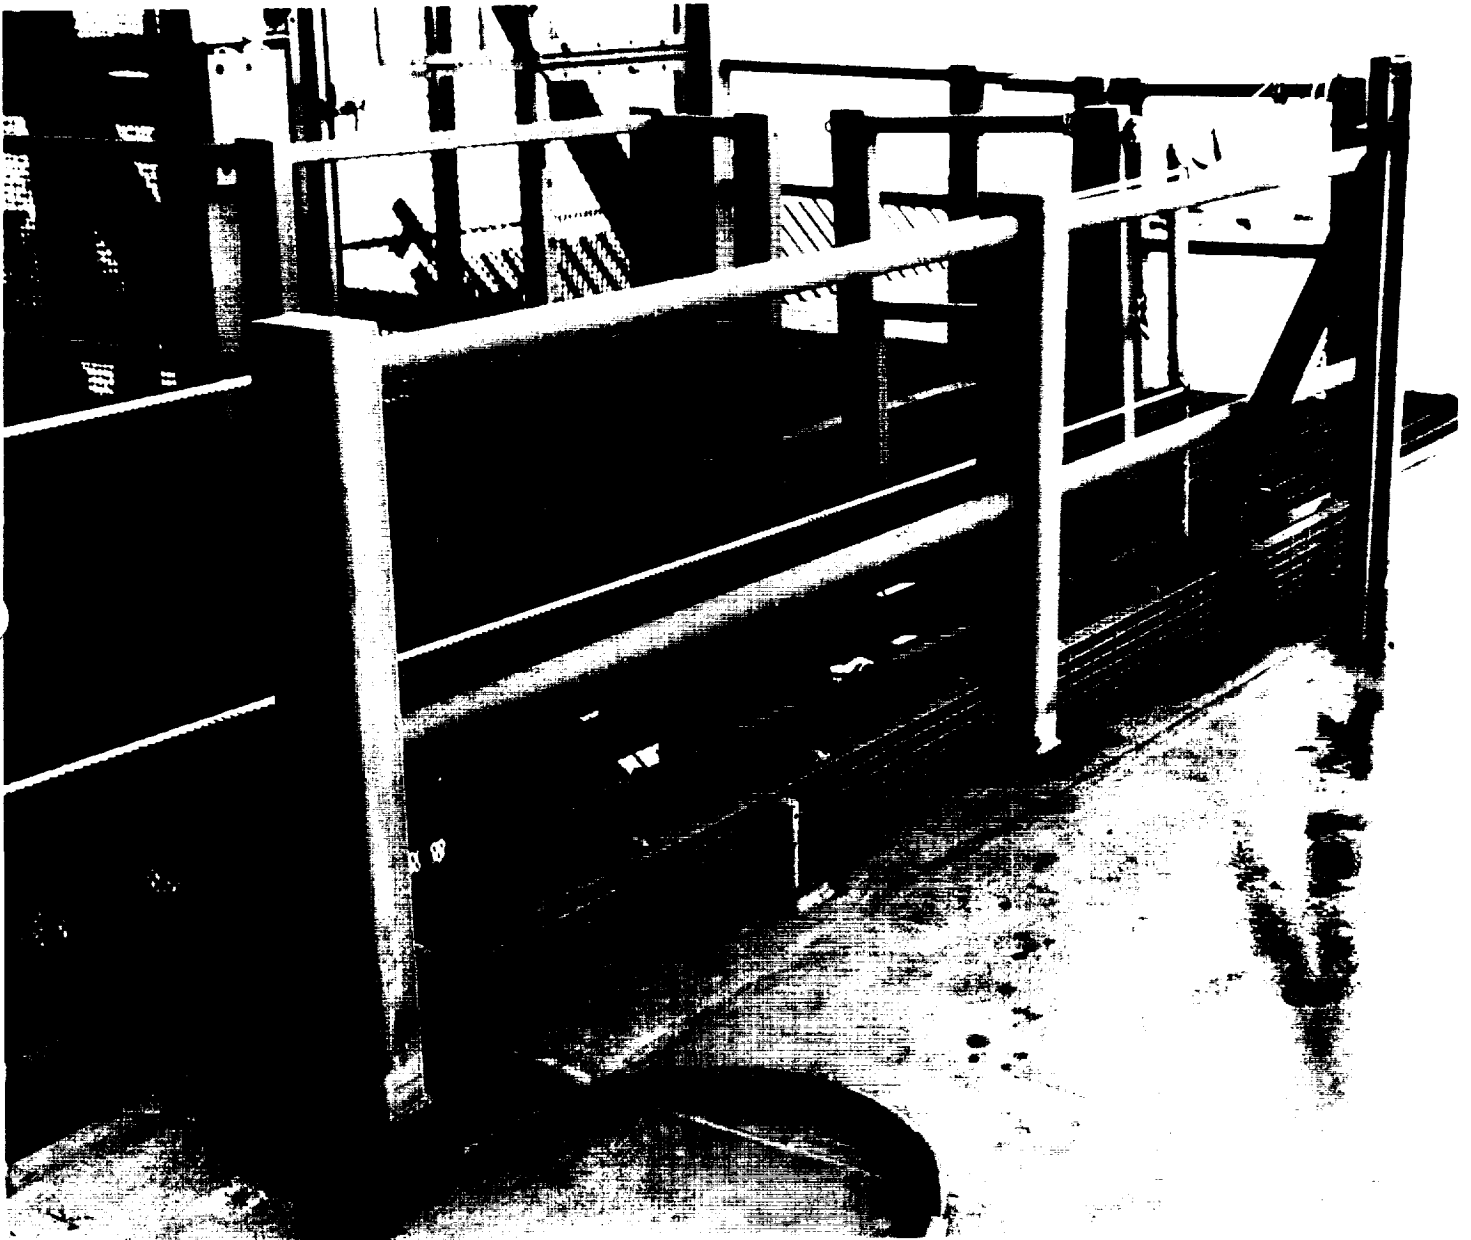
A metal washer, 1.125 inches in diameter, lay against Orbiter tile on top of the Orbiter Access Arm (OAA) inflated seal. After the washer was removed, a partial coating of white paint was found on the washer similar to that covering the nearby hypergolic fuel system access platform. No damage to Orbiter tiles was detected.

A metal washer lay against Orbiter tiles on top of the Orbiter Access Arm inflated seal. After removal, a partial coating of white paint was found on the washer similar to that covering the nearby hypergolic fuel system access platform. No damage to Orbiter tiles was detected.

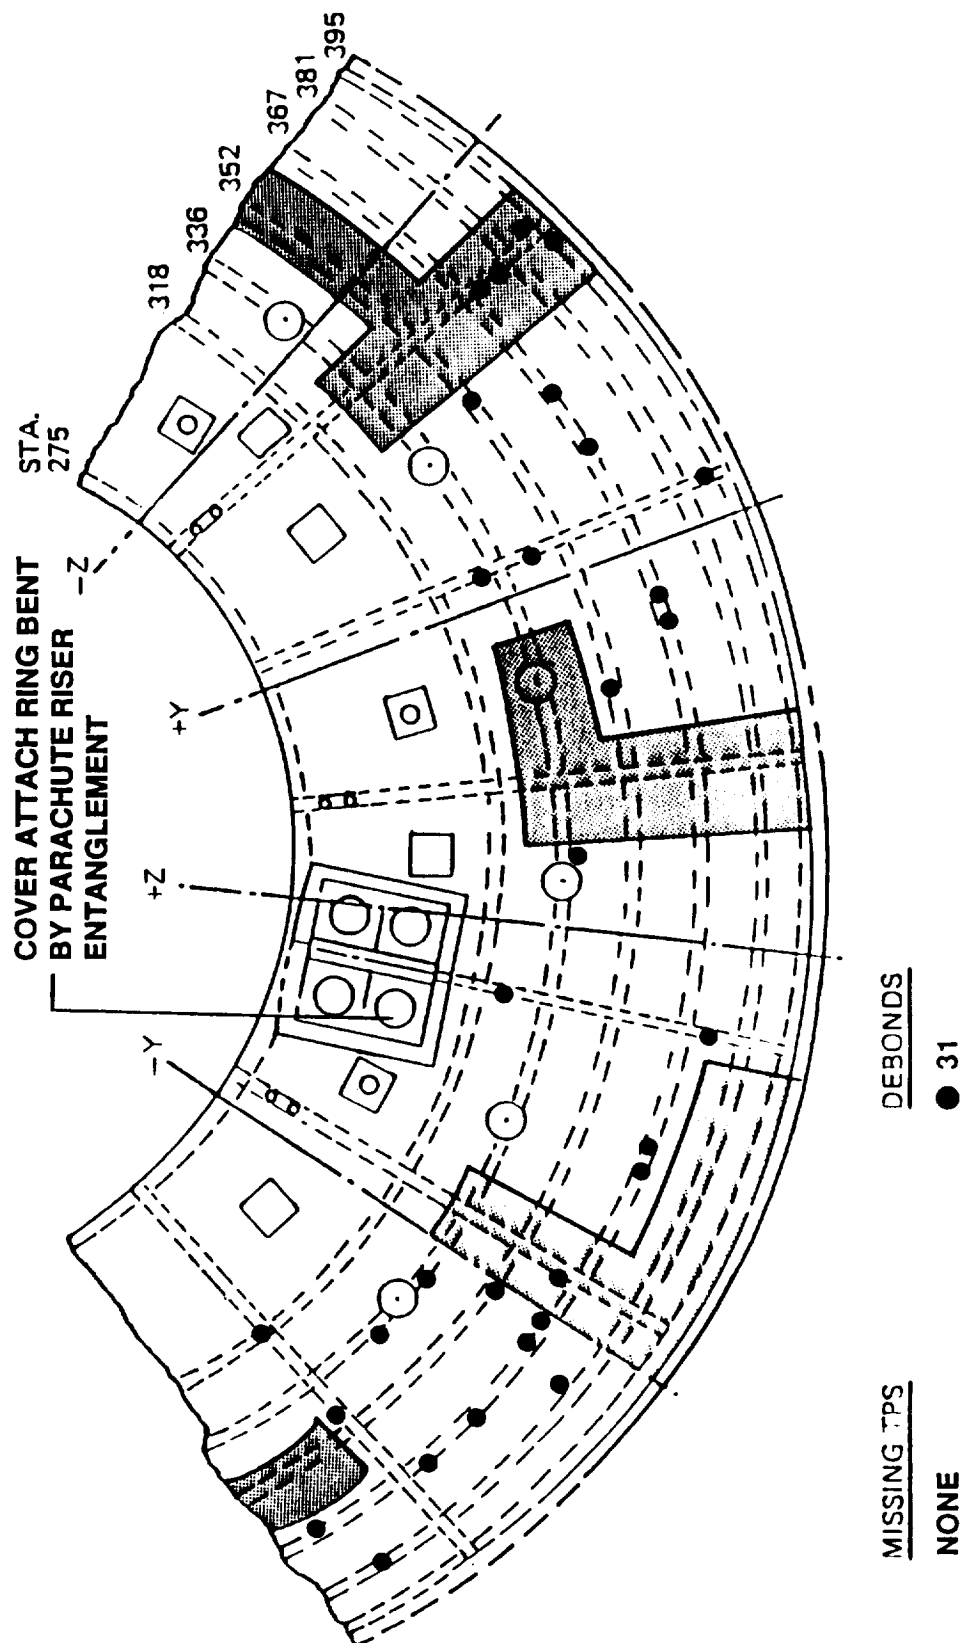
Figure 4. **RIGHT SRB FRUSTUM**

The RH frustum was missing no TPS, but had 31 MSA-2 debonds over fasteners. Minor localized blistering of the Hypalon paint had occurred along the 395 ring (Figure 4). All BSM aero heat shield covers were locked in the fully opened position though the lower left cover attach ring had been bent by parachute riser entanglement.

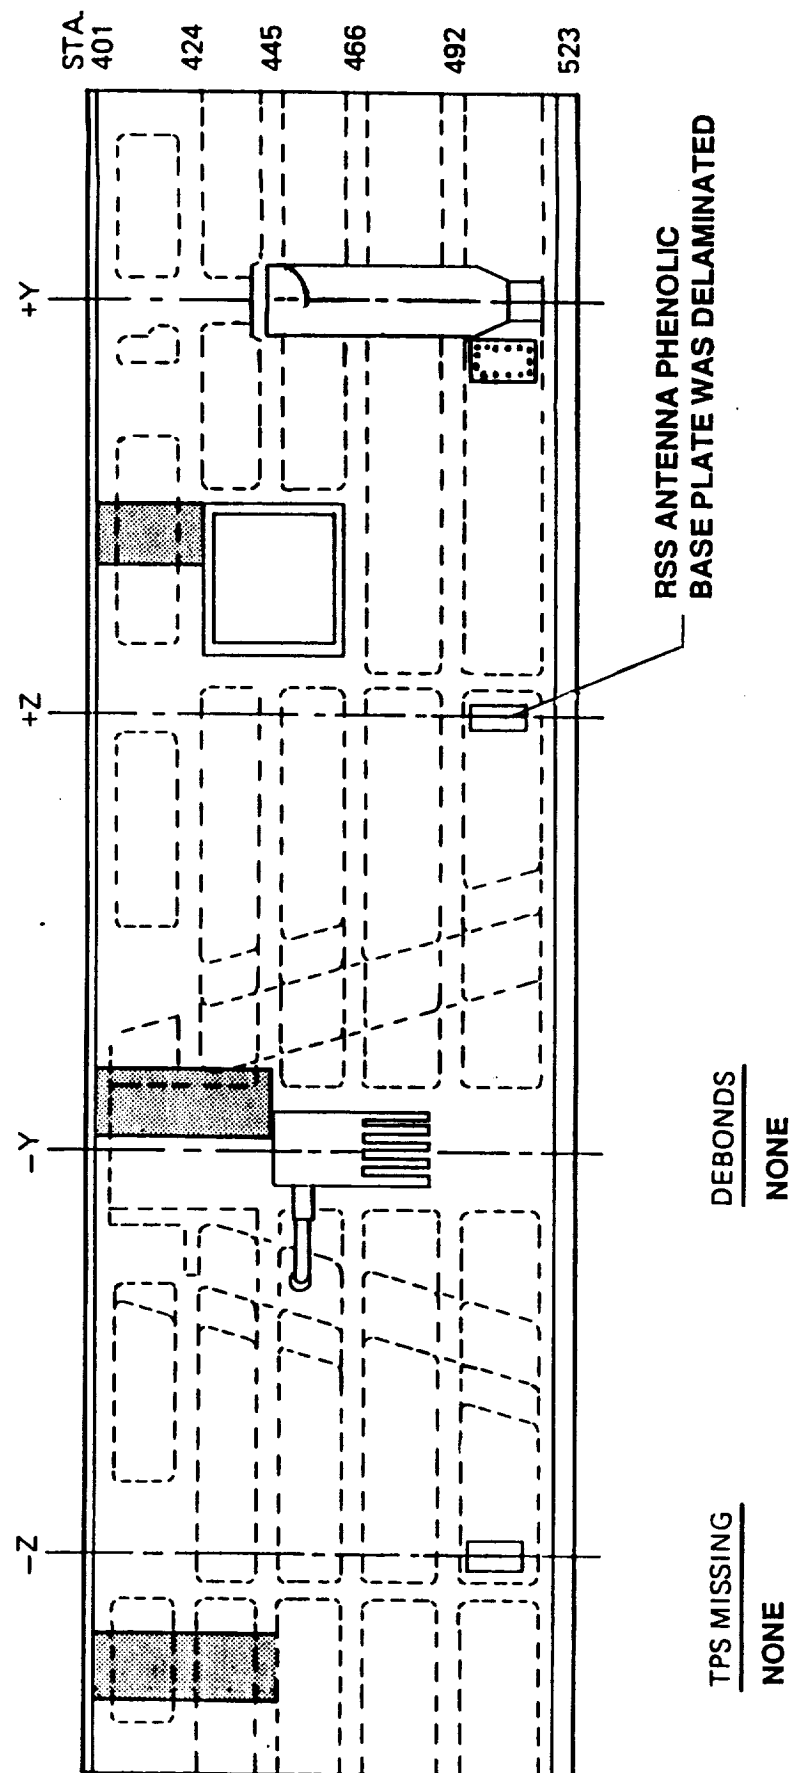
Figure 5. **RIGHT SRB FWD SKIRT**

The RH forward skirt exhibited no debonds or missing TPS. Both RSS antennae covers/phenolic base plates were intact, but the plate on the +Z antenna was delaminated. Minor blistering of the Hypalon paint occurred on the systems tunnel cover and around the ET/SRB attach point (Figure 5). No pins were missing from the frustum severance ring. The forward separation bolt and electrical cables appeared to have separated cleanly.

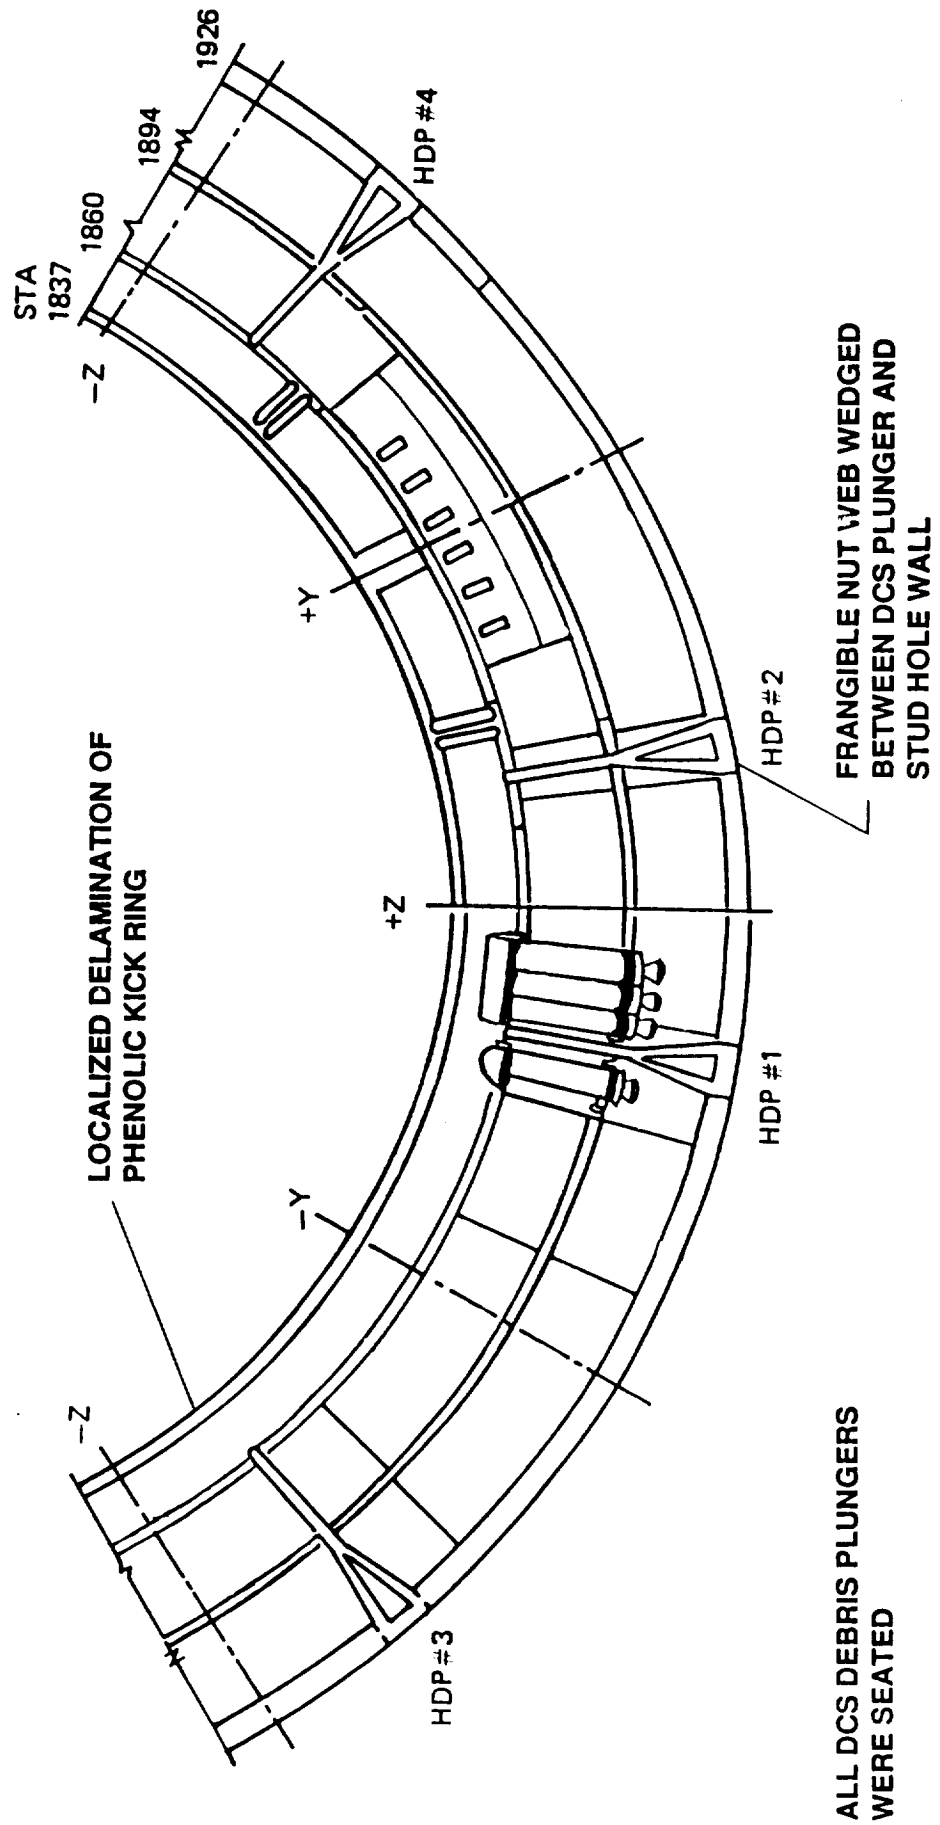
Figure 6. RIGHT SRB AFT SKIRT EXTERIOR TPS

The phenolic material on the kick ring was delaminated. The K5NA closeouts (protective domes) on the kick ring forward and aft fasteners had been eliminated. RTV-133 replaced the K5NA over the forward fasteners (Figure 6).

None of the aft skirt HDP EPON shim material was lost at lift off. Although seated, a frangible nut web was wedged between the HDP #2 DCS plunger and the stud hole wall. The other three Debris Containment System (DCS) plungers were seated properly.

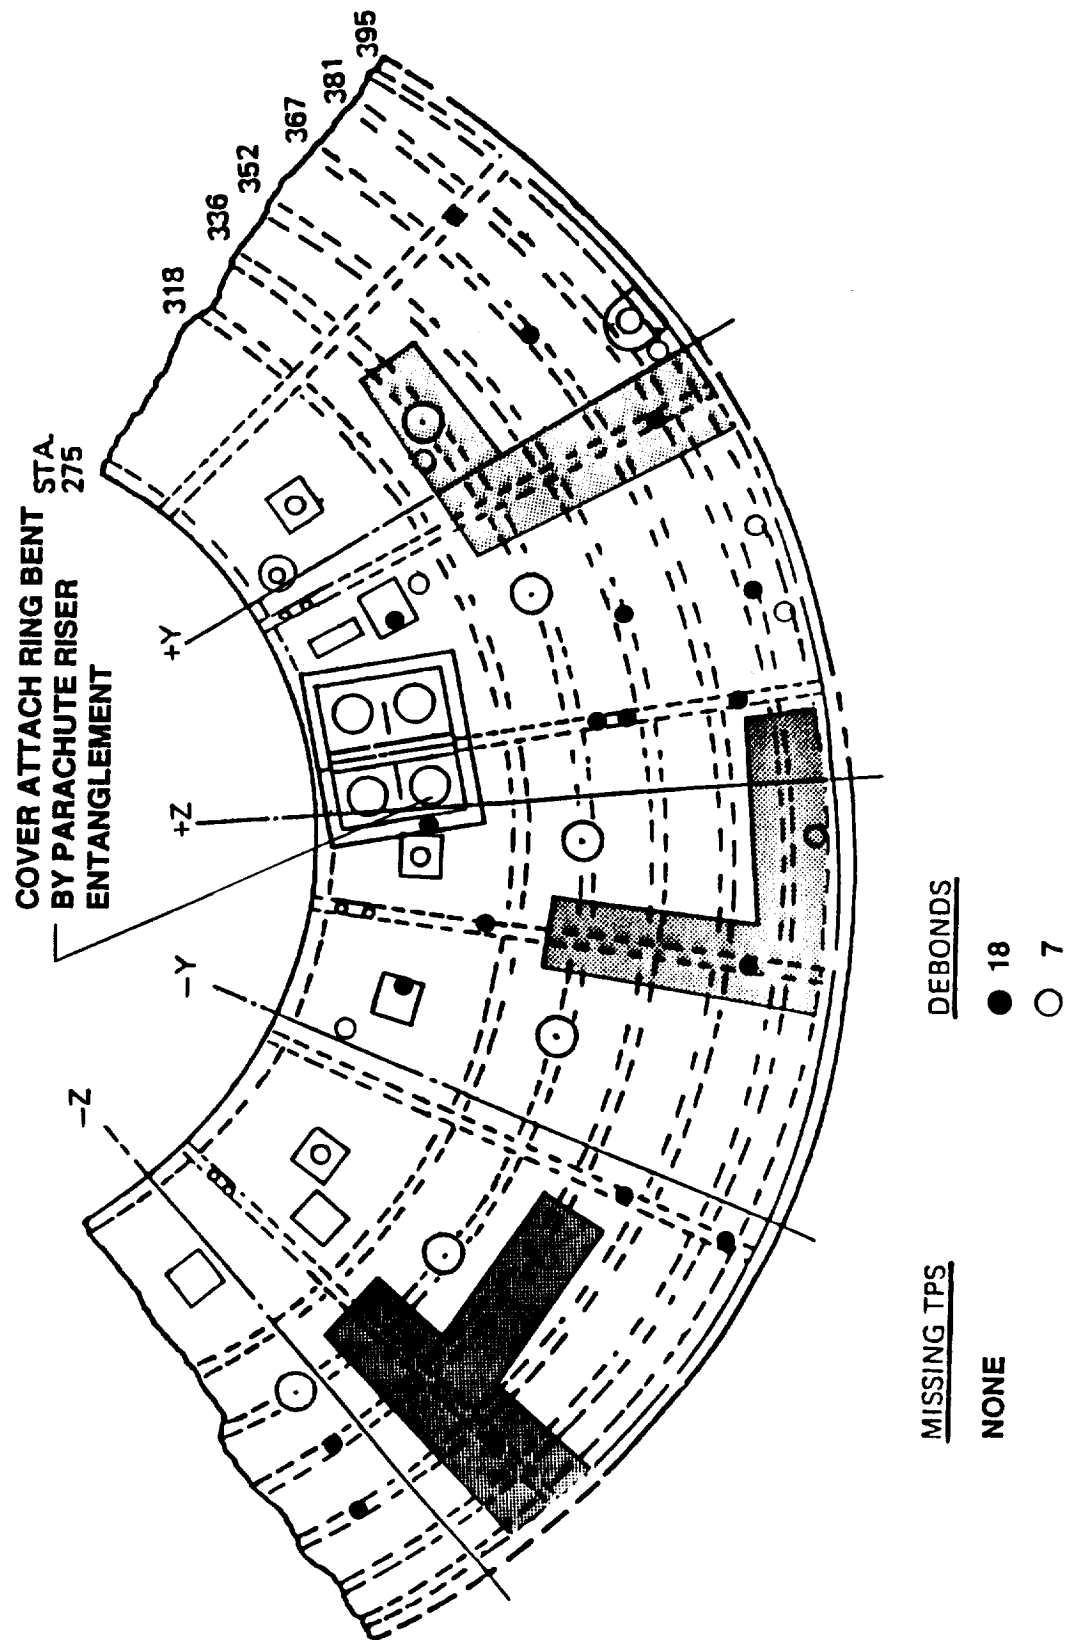
Figure 7. **LEFT SRB FRUSTUM**

The LH frustum was missing no TPS, but had 18 MSA-2 debonds over fasteners and seven acreage debonds (Figure 7). Minor localized blistering of the Hypalon paint had occurred along the 395 ring. The BSM aero heat shield covers were locked in the fully opened position, though the lower left cover attach ring had been bent by parachute riser entanglement.

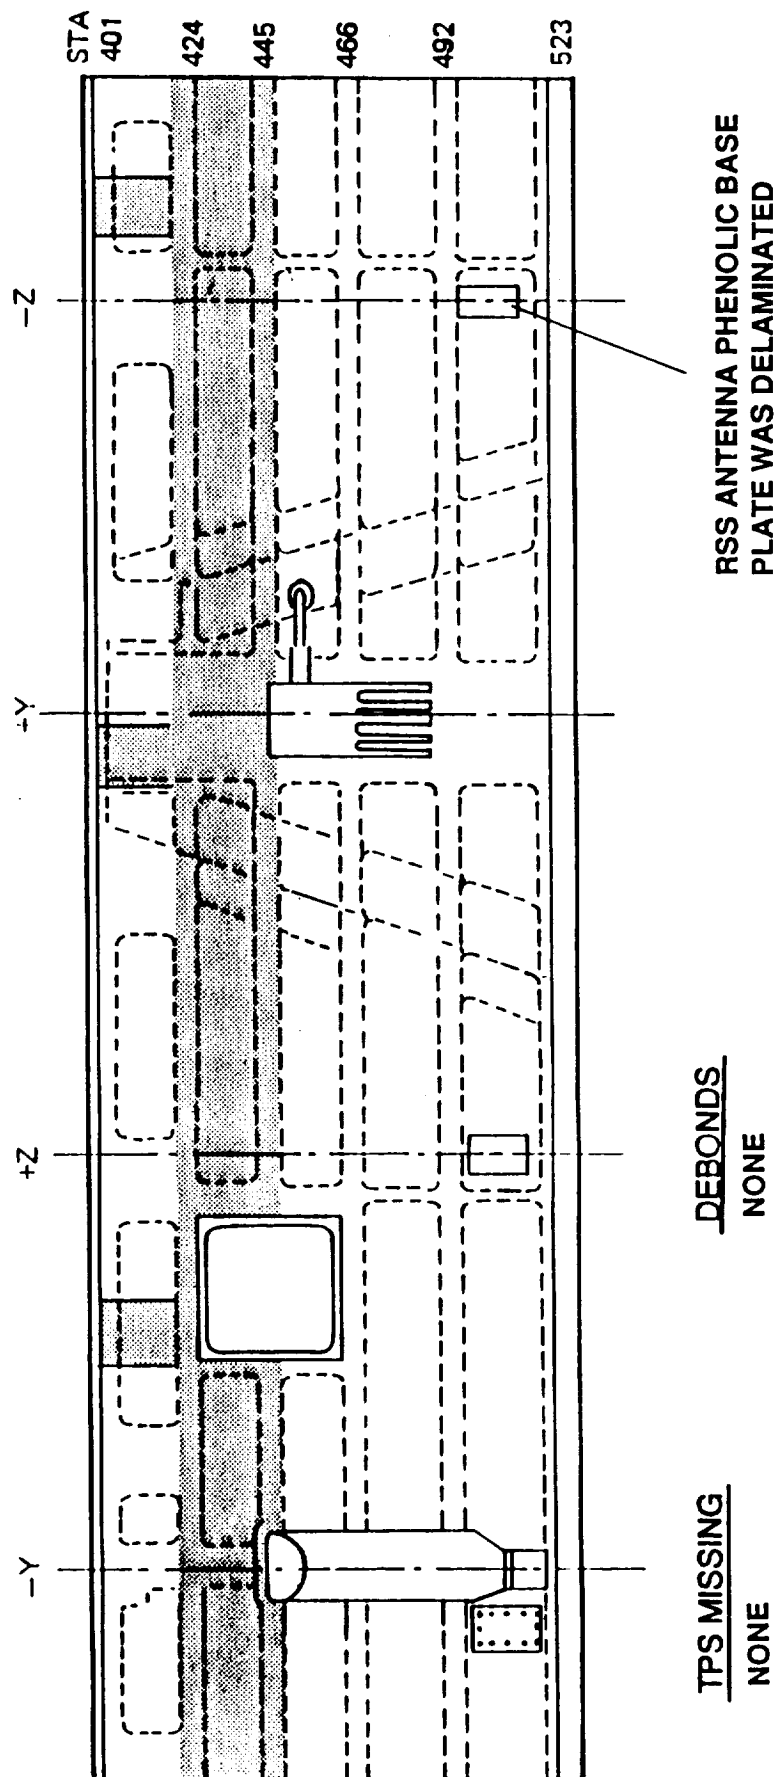
Figure 8. **LEFT SRB FWD SKIRT**

The LH forward skirt exhibited no debonds or missing TPS. The phenolic plates on both RSS antennae were intact, but the -Z plate was delaminated. Minor blistering of the Hypalon paint occurred near the ET/SRB attach point and on the systems tunnel cover (Figure 8). No pins were missing from the frustum severance ring. The forward separation bolt and electrical cables appeared to have separated cleanly.

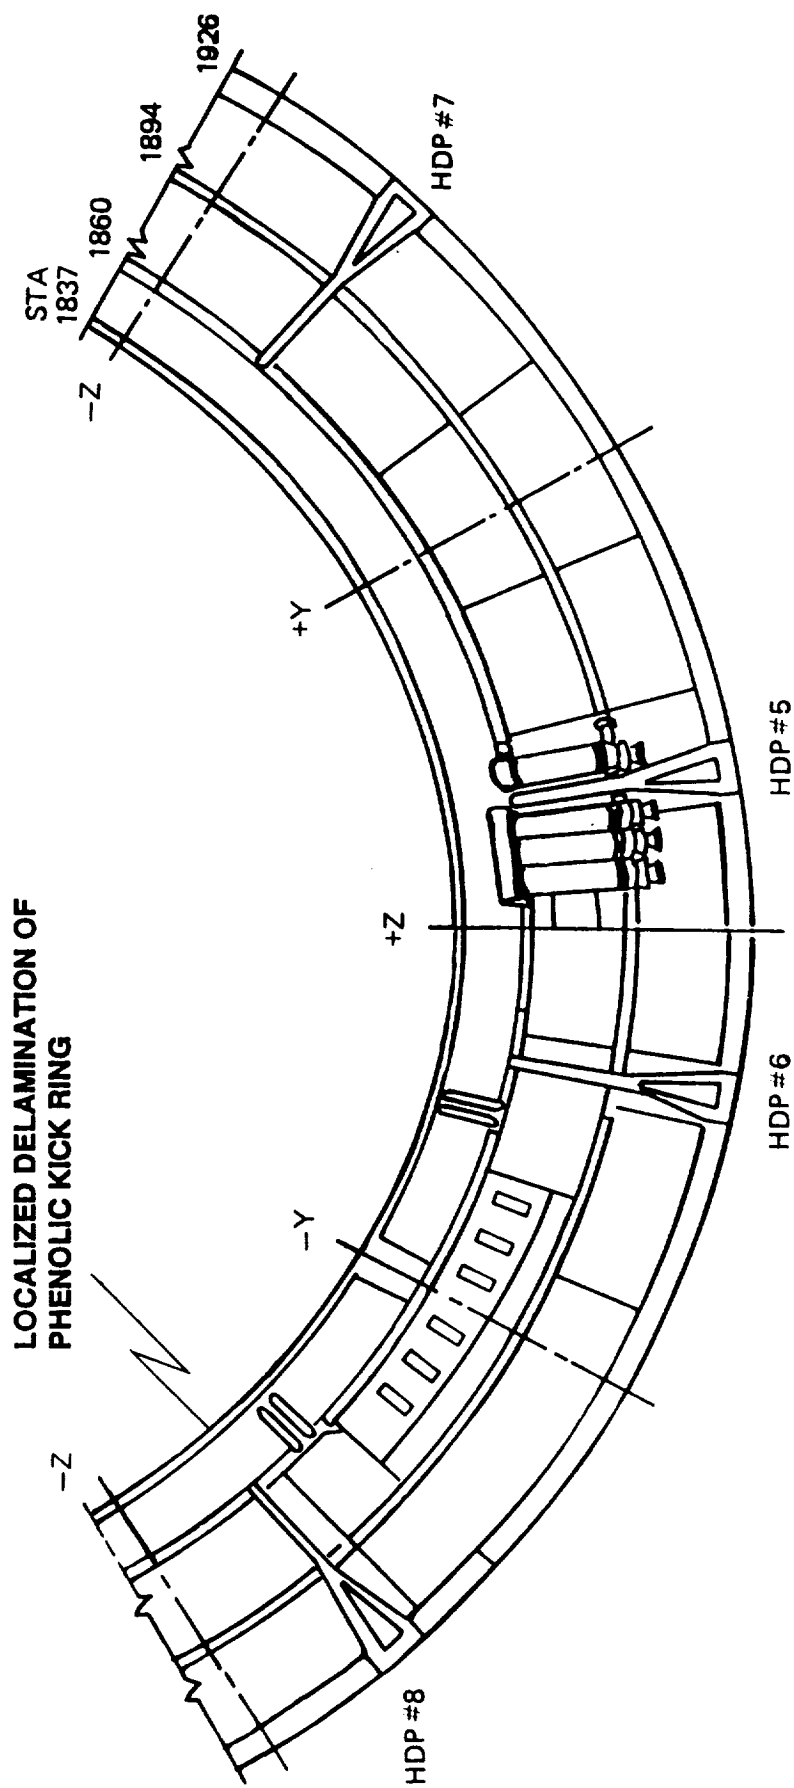
Figure 9. LEFT SRB AFT SKIRT EXTERIOR TPS

The phenolic material on the kick ring was delaminated in only localized areas. The K5NA closeouts (protective domes) on the kick ring forward and aft fasteners had been eliminated. RTV-133 replaced the K5NA over the forward fasteners (Figure 9)

ALL DCS DEBRIS PLUNGERS  
WERE PROPERLY SEATED

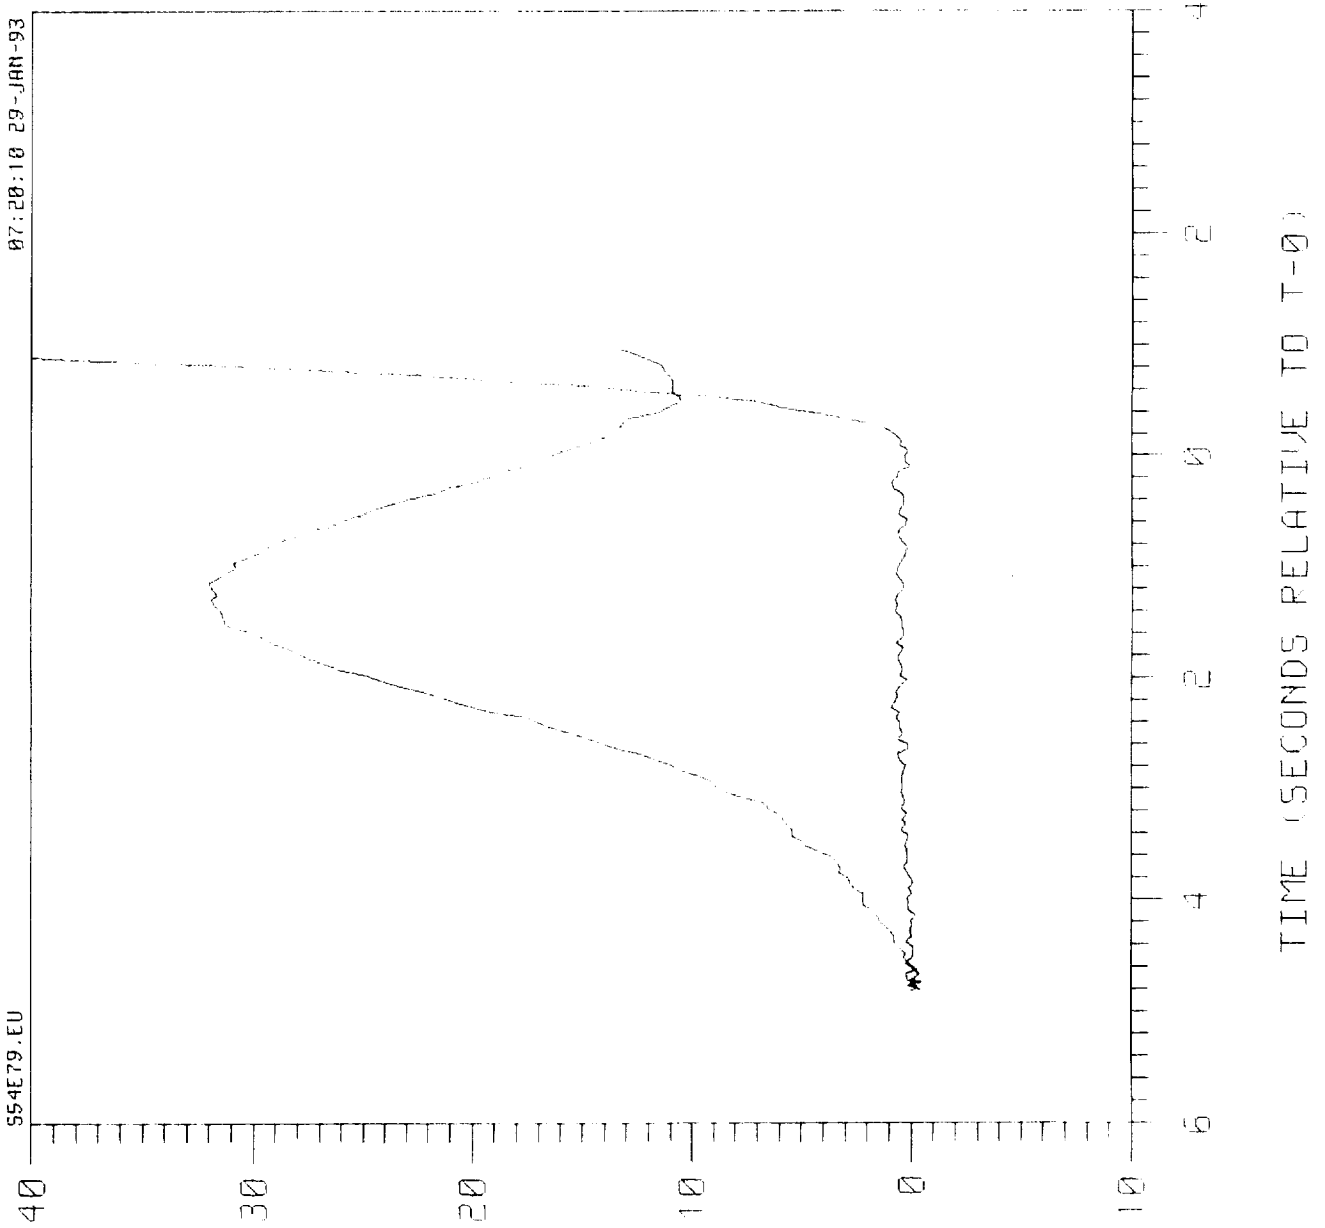
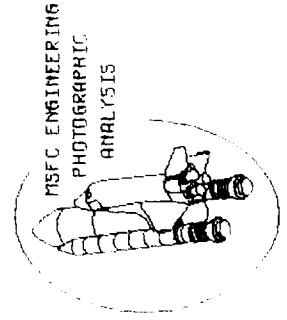
Figure 6

# ET TIP DEFLECTION
